LOSS OF THE STEAMSHIP "TITANIC"

REPORT

REPORT ON THE LOSS OF THE STEAMSHIP "TITANIC."

REPORT OF A FORMAL INVESTIGATION INTO THE CIRCUMSTANCES
ATTENDING THE FOUNDERING ON APRIL 15, 1912, OF THE BRIT-
ISH STEAMSHIP TITANIC, OF LIVERPOOL, AFTER STRIKING
ICE IN OR NEAR LATITUDE 41° 48' N., LONGITUDE 50° 14' W.,
NORTH ATLANTIC OCEAN, WHEREBY LOSS OF LIFE ENSUED.

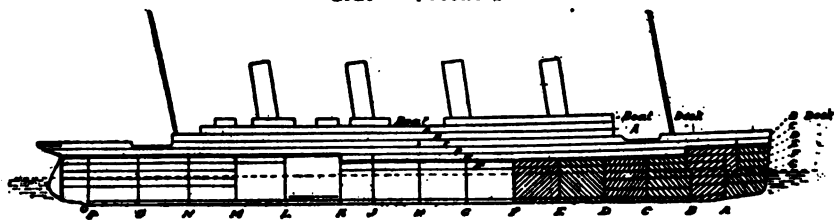
S.S. "TITANIC."

The collision with the iceberg, which took place at 11.40 p. m., caused damage to the bottom of the starboard side of the vessel at about 10 feet above the level of the keel, but there was no damage above this height. There was damage in—

The damage extended over a length of about 300 feet.

It will thus be seen that all the six compartments forward of No. 4 boiler room were open to the sea by damage which existed at about 10 feet above the keel. At 10 minutes after the collision the water seems to have risen to about 14 feet above the keel in all these compartments except No. 5 boiler room. After the first ten minutes the water rose steadily in all these six compartments. The forepeak above the peak tank was not filled until an hour after the collision, when the vessel's bow was submerged to above C deck. The water then flowed in from the top through the deck scuttle forward of the collision bulkhead. It was by this scuttle that access was obtained to all the decks below C down to the peak tank top on the orlop deck.

NOTE.—The vertical letters signify the different decks. The horizontal letters signify the watertight bulkheads. The heavy line shows the top of the watertight bulkheads. The cross-hatched compartments are those opened to the sea at the time of the collision with the iceberg.
